# Native Restoration Management Plan Scamander Pine Plantation, Tasmania June 2013

Prepared for the Northeast Bioregional Network

Bushways

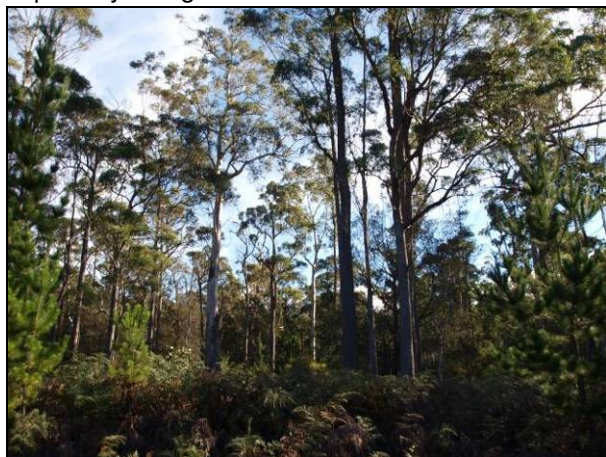
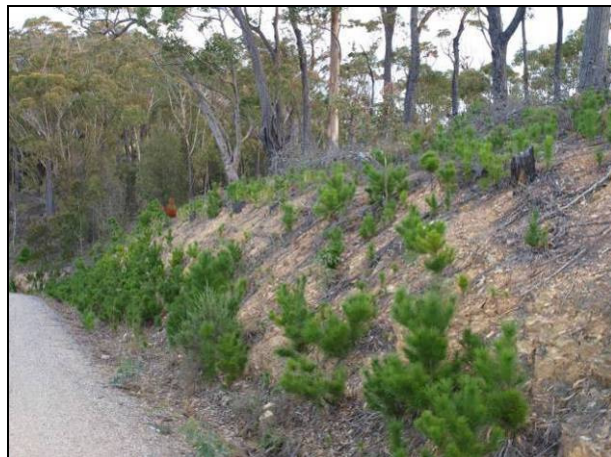
Figures 6 and 7. Adjoining native forest on reserved land with pine invading from roadside, near sites 38 and 20.

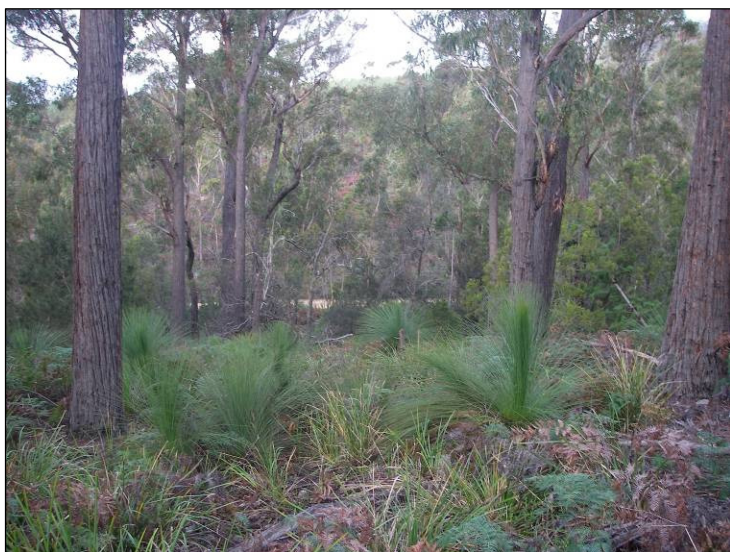
Figure 9. Site 45: Ironbark remnant in excellent condition, adjacent to pine plantation.

Some of these remnants, such as the blue gum forest at site 10, are floristically intact and, having undergone some previous pine control, are in good condition. One small ironbark forest remnant, site 45, is in excellent condition with no pine present and a diverse understorey with twiggly waxflower and grasstrees.

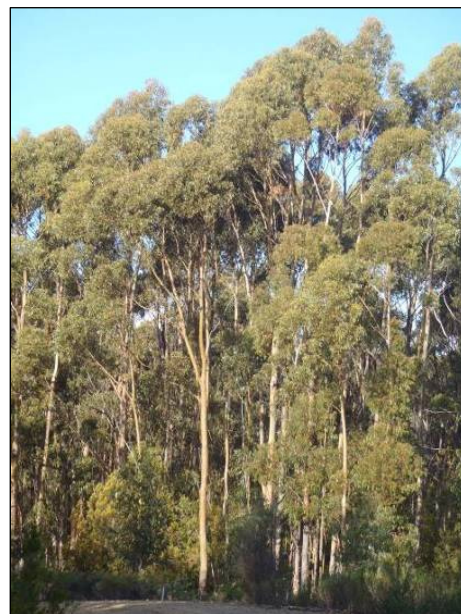
Figure 8. Site 10: Blue gum remnant, in excellent condition following pine removal.

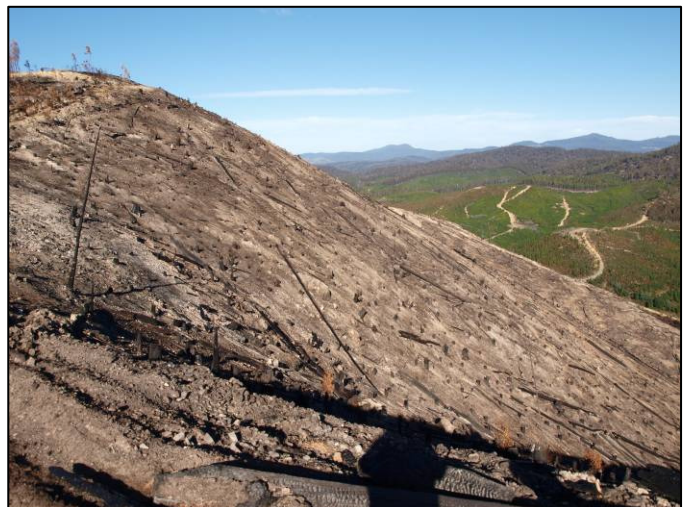
Sites which have been recently harvested and burnt and are almost devoid of vegetation are evident on the western side of Skyline Tier. The burns have evidently been hot and thorough.

Steep hills prone to soil loss are a risk for these sites. A heavy storm event at this time may cause issues for stream sedimentation downhill and seed germination on site. However, the fire could be seen as a onetime event, similar to a hot bush fire, with positive benefits for restoration of native vegetation as experienced on sites 23 and 27.

*Figure 18. Site 29: Recently burnt , bare of vegetation.*

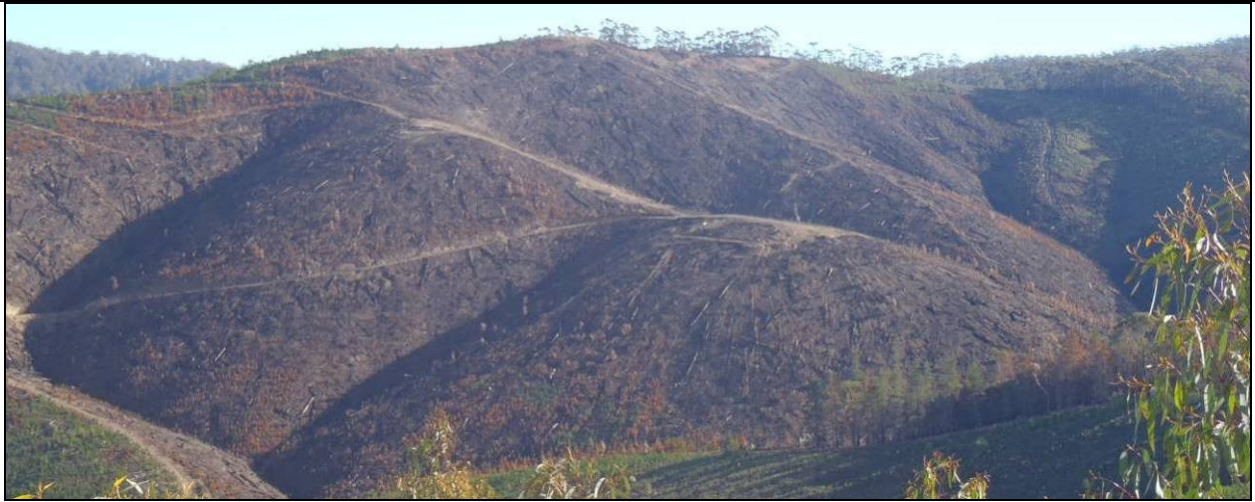
*Figure 19. Site 25: Hills with little or no vegetation cover at all at the time of survey - the result of recent pine harvest followed by a hot fire.*

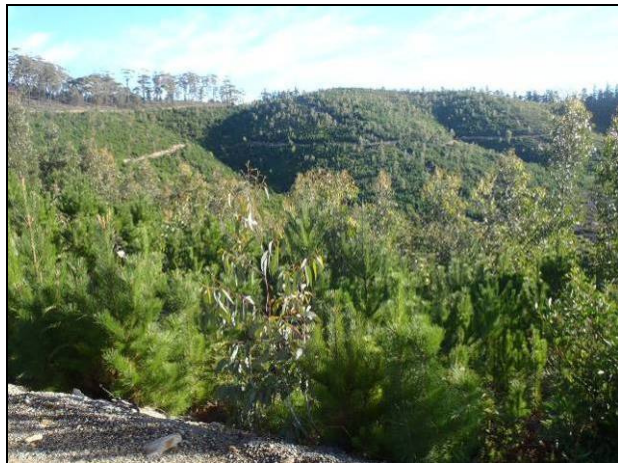
*Figure 21. Site 16: Has many pines with native regeneration and needs burning for efficient pine control.*

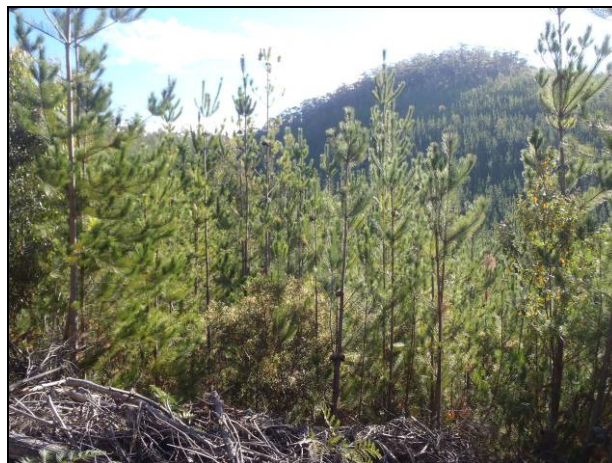
*Figure 22. Site 4: Similar to site 16, but taller in places.*

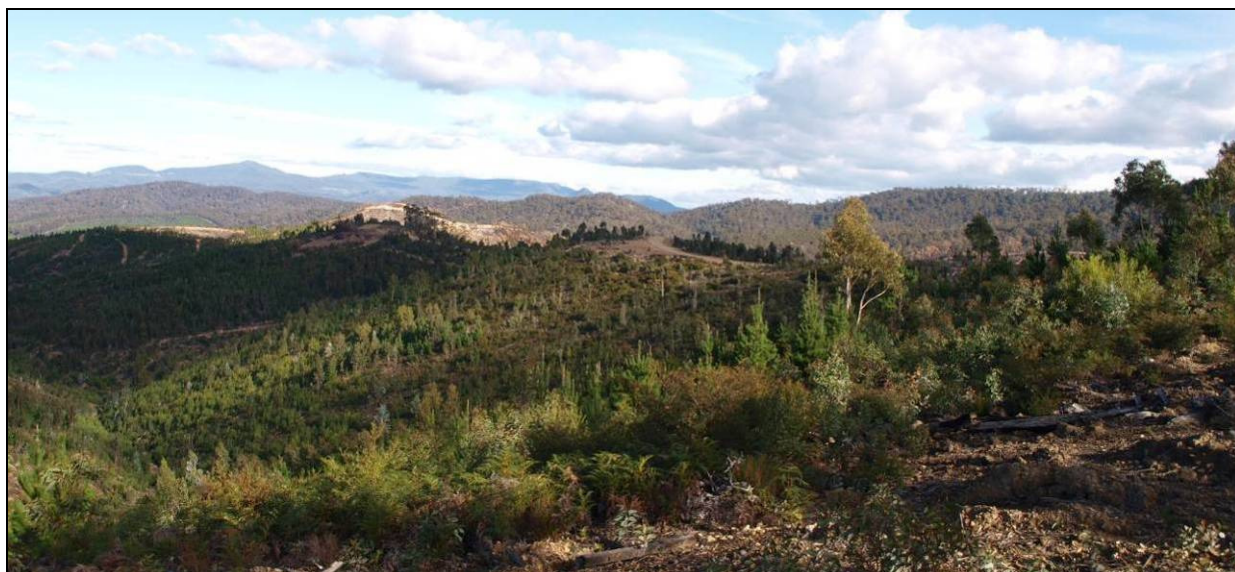
*Figure 23. Site 28: Looking south from the northern end, regeneration of native and pine mixed, unlikely to have been burnt, or if burnt in patches the burn was not hot enough to kill pine.*

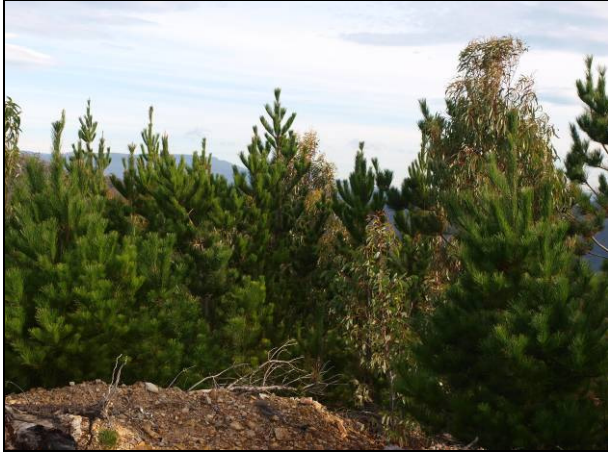
*Figure 24. Site 20: Pine dense and getting tall, up to four metres high. Mixed with good native regeneration, and a large area on a steep slope, pine control methods other than fire are not viable.*

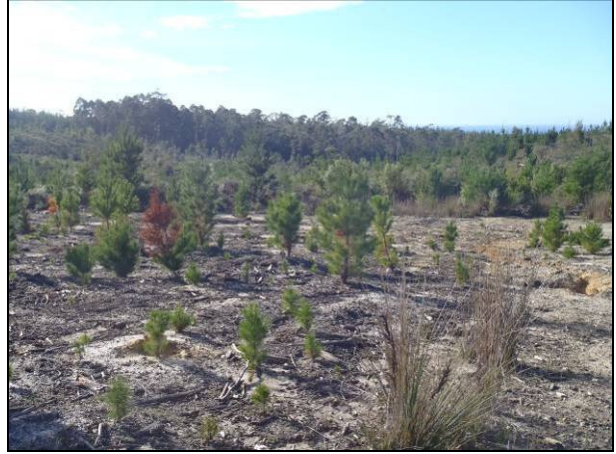
*Figure 25. Site 9: Was aerial sprayed and replanted with pine which are yellowing and there is no native regeneration.*

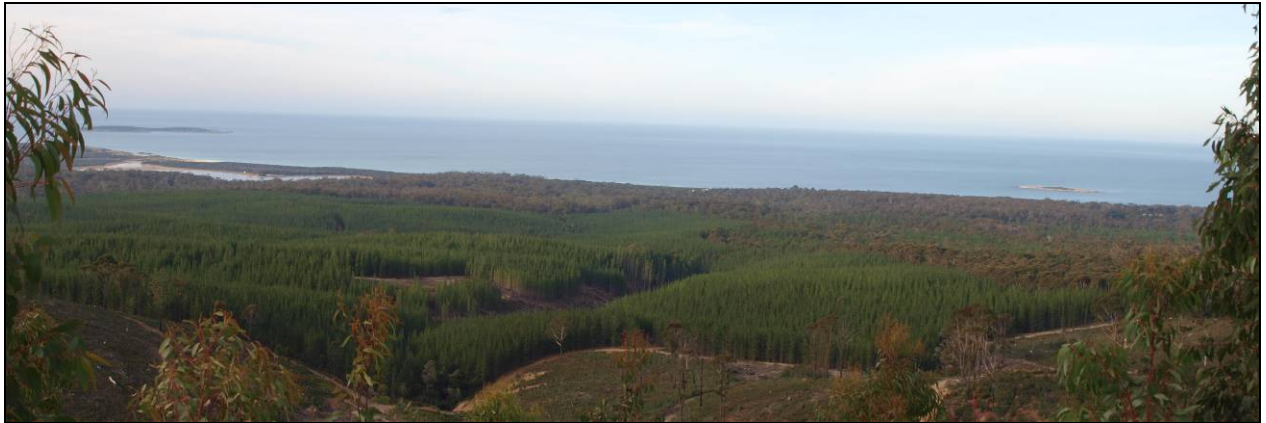
*Figure 26. Site 19: A very large area of mostly pine in the Diana's Basin catchment. The occasional eucalypt patch is evident, good native remnants adjoin and good native restoration areas are upslope.*

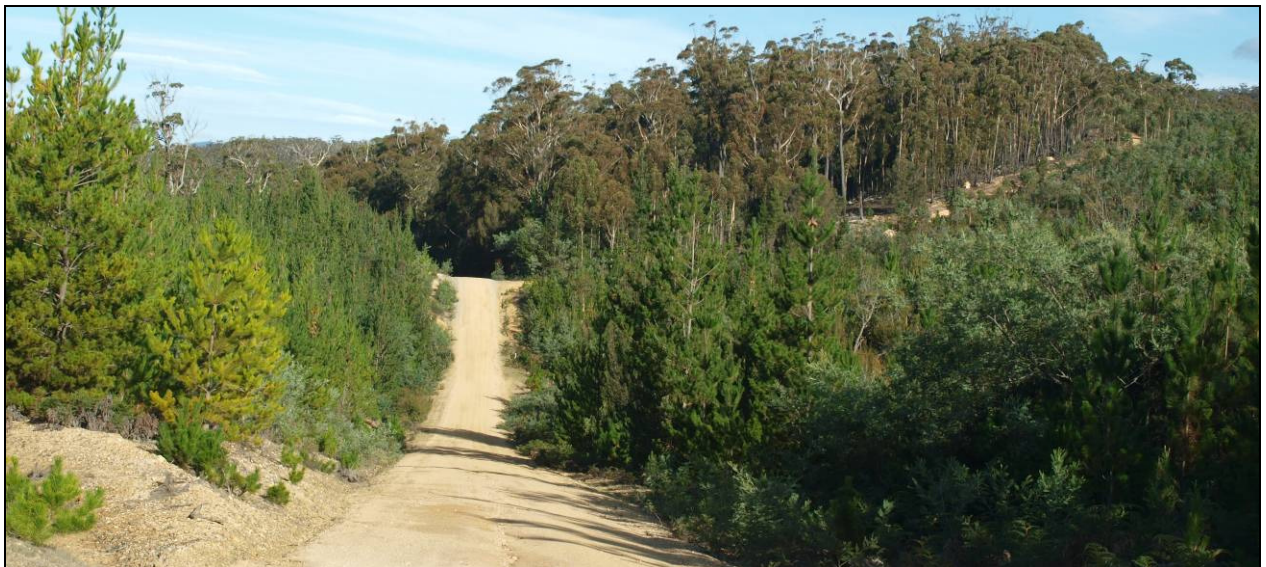
*Figure 27. Site 37: Dense pine adjacent to and surrounded by native forest reserve.*

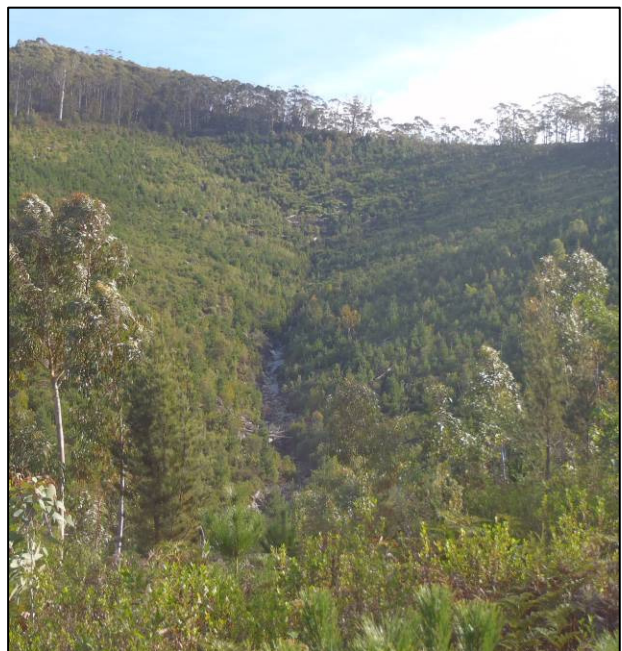
As an upper catchment area, the topography of Scamander Plantation is featured by small gullies with ephemeral watercourses. Several sites exhibit streams such as the one pictured right in site 11, a harvested and regenerating area with a steep gully actively eroding. In time vegetation will help to stabilise this but meanwhile sediment transfer is occurring constantly. There is risk of major erosion and soil loss with severe storm events. There are sites across the plantation where erosion is occurring before it can be arrested by revegetation. In some instances erosion may prevent the establishment of seedlings.

*Figure 29. Site 11: Gully erosion evident.*

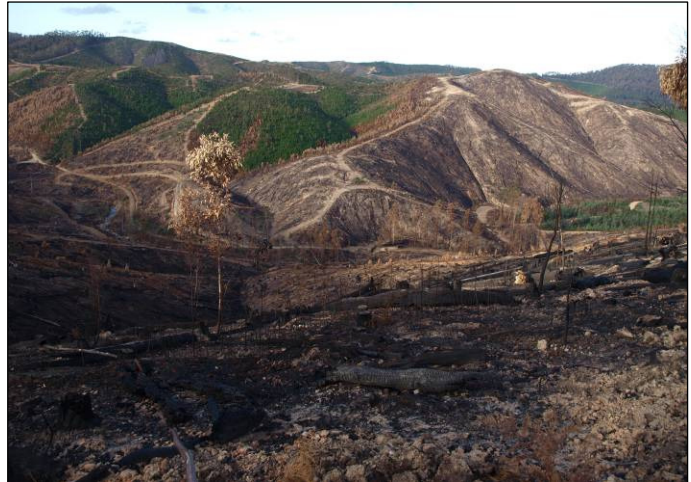
Some recently harvested coupes have streams totally devoid of vegetation and pine has clearly been harvested from stream banks and channels followed by burning. Arm Creek and its tributaries have been heavily impacted by plantation activities, indicated by lack of vegetation, wide and deep channels, bank and channel erosion, excessive sedimentation and discoloured water.

Riparian zones in or adjoining the recently harvested or burnt areas are currently lacking in vegetation cover and are at high risk of erosion and sedimentation, lineal downstream impacts. These streams are without shade and are therefore subject to temperature extremes. Habitat opportunity in these sites is currently very poor. Sites downstream of these sites are impacted by sedimentation and erosion.

*Figure 30. Riparian zone of Arm Creek in site 29: Recently harvested and burnt. Leaving the patch of wattles and other natives in downstream riparian zone, site 29a, is essential until the upstream zone recovers, then follow up with low impact pine removal.*

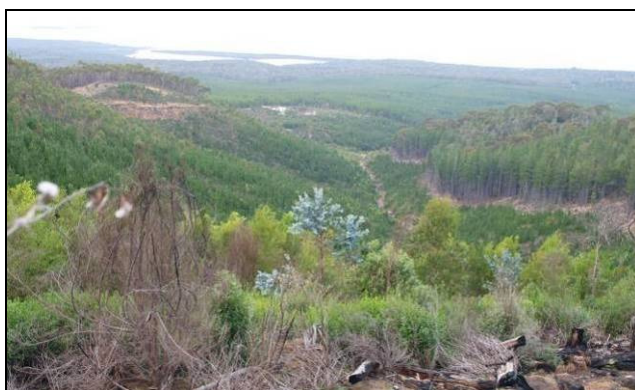
The Diana's Basin site below was not burnt after harvest 7 years ago and, although native regeneration has been excellent, the pines are dense and persistent. The steepness of the slope and extent of the area means that manual and mechanical controls are not ideal and are inefficient. Had the site been burnt it is likely that regeneration now would be as good as site 2.

*Figure 40. Diana's Basin site: 2013, good native regeneration with dense pine regrowth on lower slopes.*

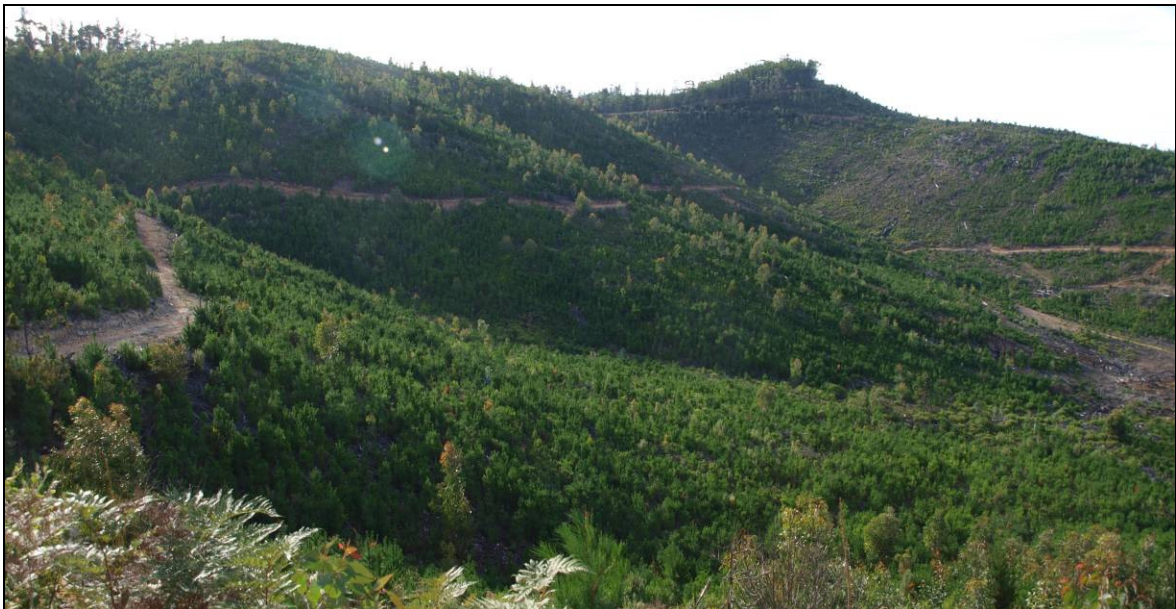
*Figure 44. Site 16: Pine regrowth is too dense and vigorous here for manual or mechanical weeding to be an effective or efficient option. A hot fire is recommended - use tracks as firebreaks and burn in sections.*

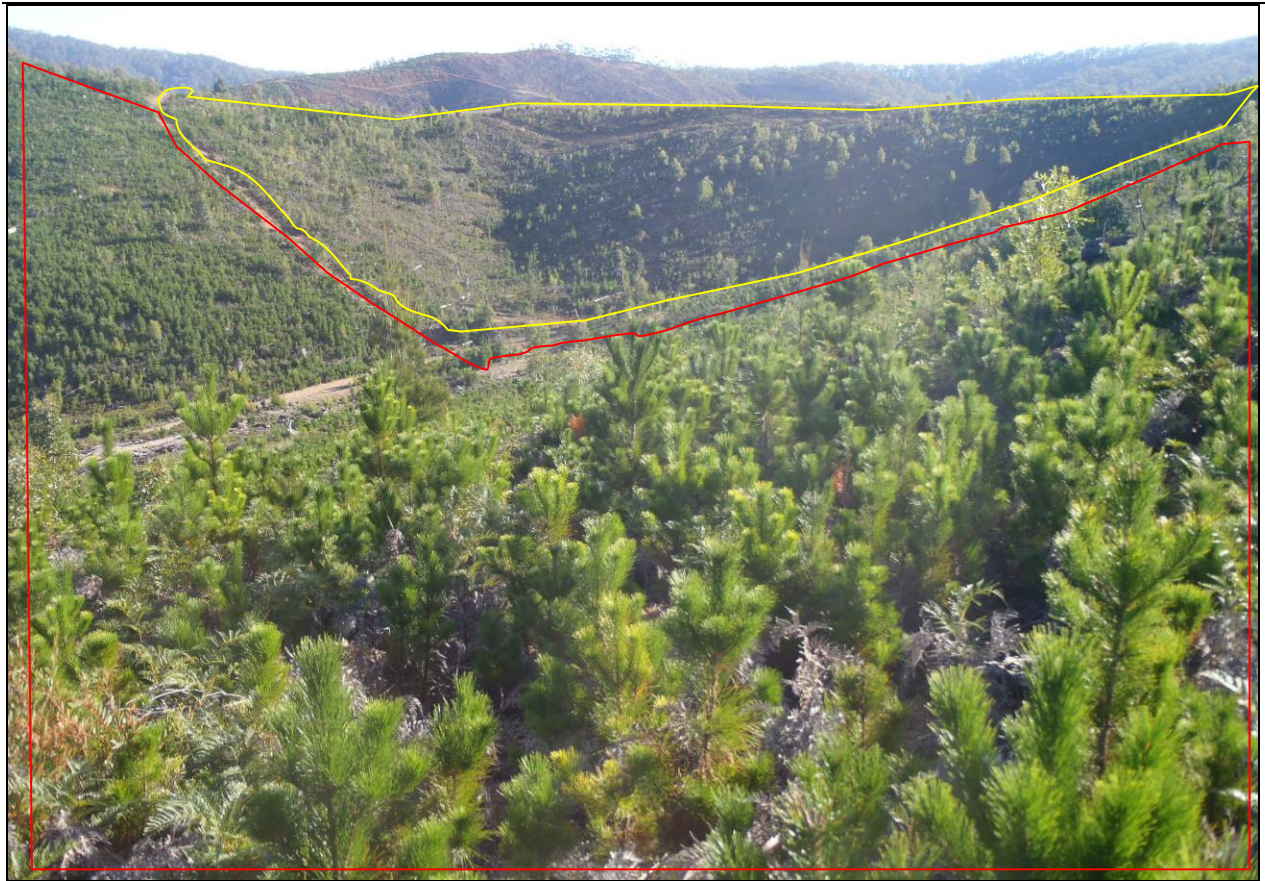
Figure 45. Site 24: In foreground and on left of hill opposite, pine regrowth vigorous, native regeneration present but pine requires burning for optimum control and native regeneration (red line). Good patch of native regeneration with little pine on hill to north (yellow line), protect from fire and manual weed control recommended.

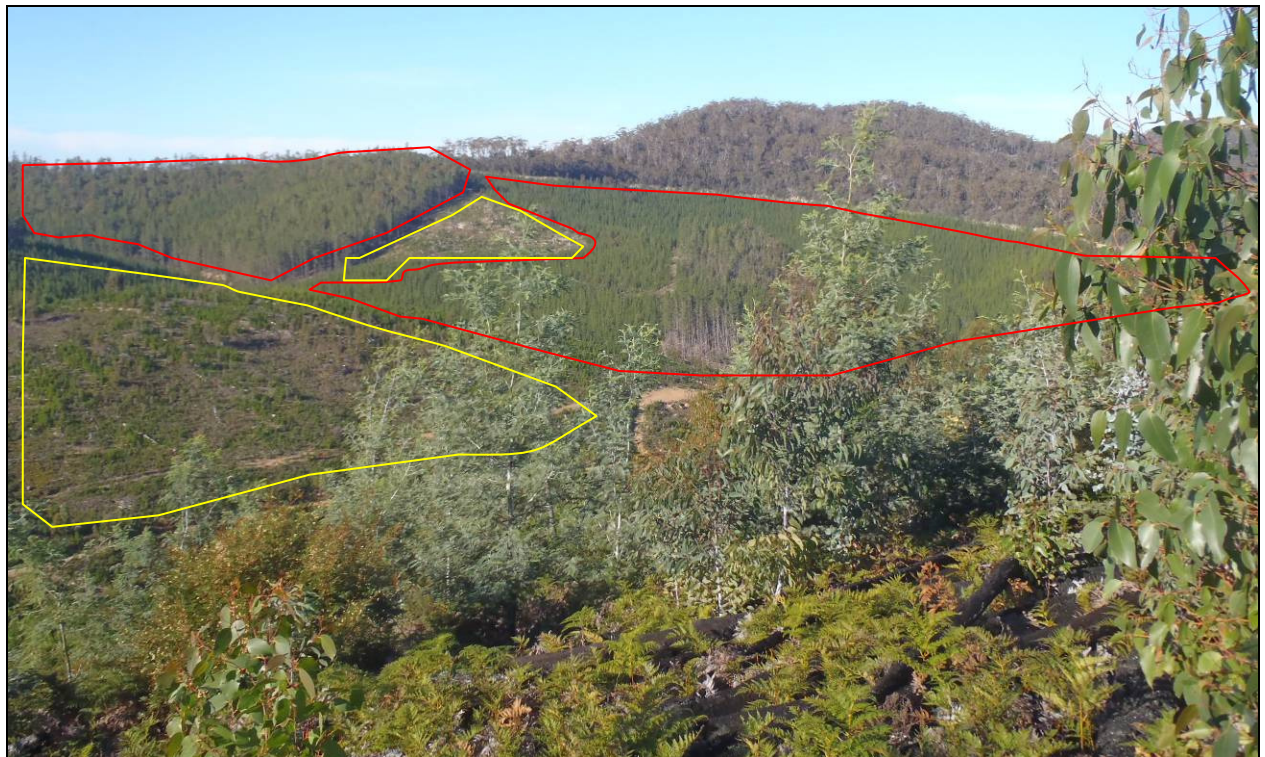
Figure 46. Site 20: Looking east from Sunshine Hill, pines in different age groups, require burning soon to promote native restoration (yellow line) and harvesting and burning in stages (red lines).

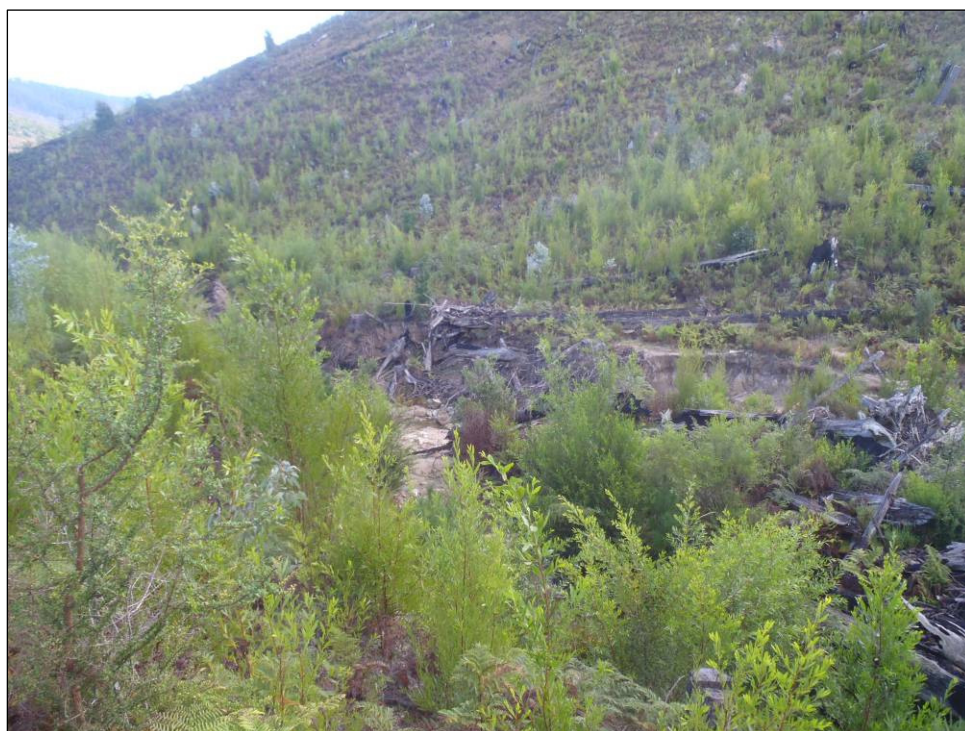
*Figure 49. On Monzenite Rd below site 23: This stream channel and riparian area are likely to recover over time, native vegetation is regenerating well, the debris in the stream channel will support banks and channel structure and little pine is present so further impacts from pine control are likely to be minimal. Future upstream coupe management should consider the rehabilitation issues for downstream sites.*

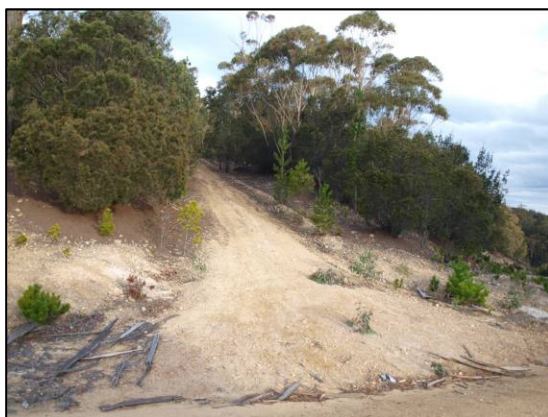
Figure 50. Well used road opposite site 20: a known firewood gathering area.

The size of the area, the easy access and number of roads, and traditional use all make control of access very difficult. Close some roads to reduce access, install signage about the project and its aims to raise awareness, and impose and increase fines for theft and dumping.
