# Native Restoration Management Plan Scamander Pine Plantation, Tasmania June 2013

Prepared for the Northeast Bioregional Network

Bushways

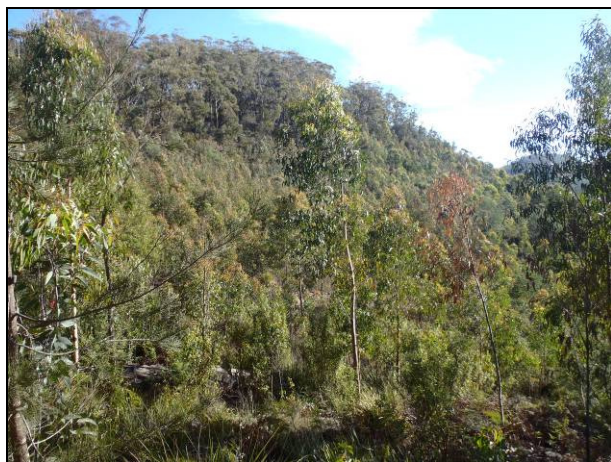
*Figure 11. Site 2: May 2013, nearly all native after burning and hand weeding.*

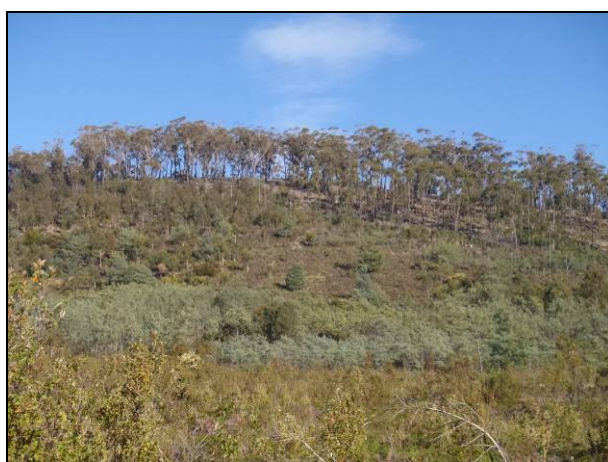
*Figure 12. Sites 2 & 3: May 2013, very little pine remaining.*

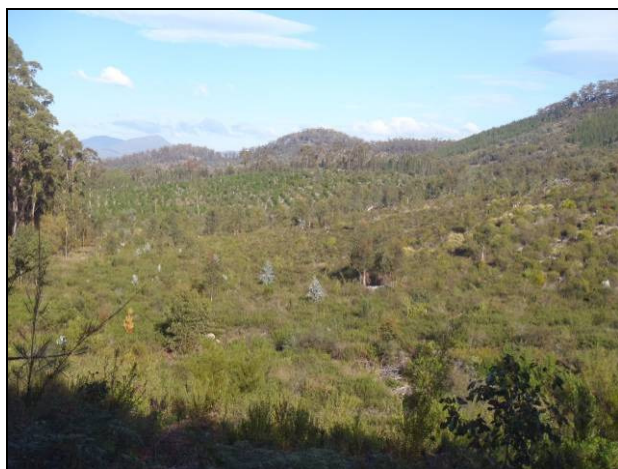
*Figure 13. Site 10: Blue gum and black gum regeneration after pine control, This site is adjacent to the blue gum forest remnant.*

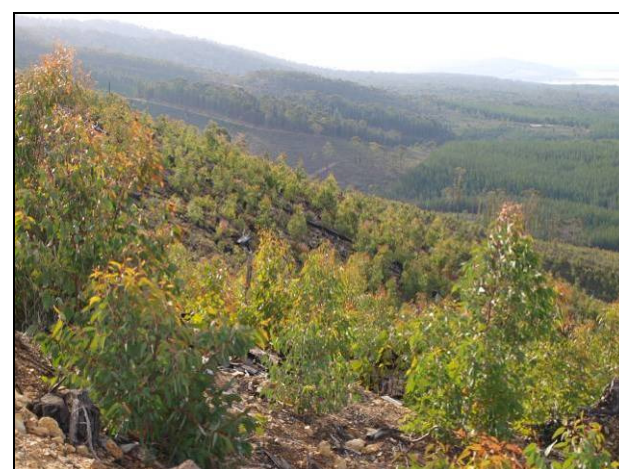
*Figure 14. Site 17: Prolific ironbark regeneration after burning and aerial reseeded with four eucalypt species, pine control since then has been manual.*

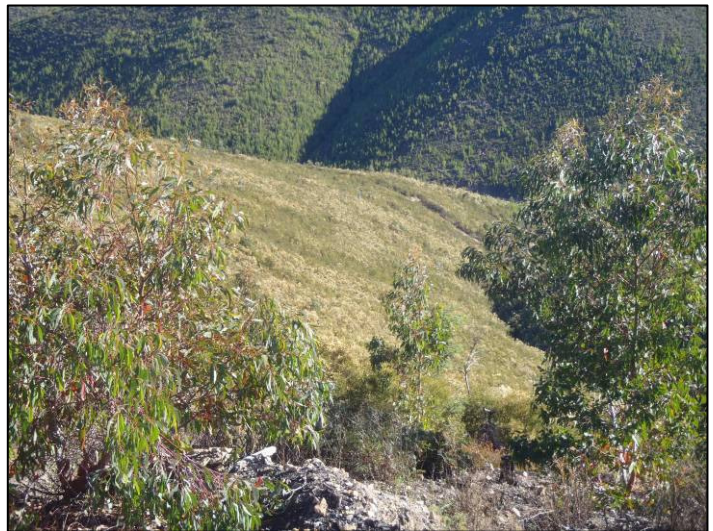
The effect of fire on promoting native forest regeneration is evident at sites 23, 26 and 27 where native regeneration is vigorous and very little pine is present two years after a post harvest burn. Species diversity is high and includes ironbark and blue gum, blackwood, sunshine wattle, mint bush, prickly box, red stem wattle and daisy bush.

*Figure 15. Site 23 in the foreground with sunshine wattle flowering profusely, and site 27 in the background.*

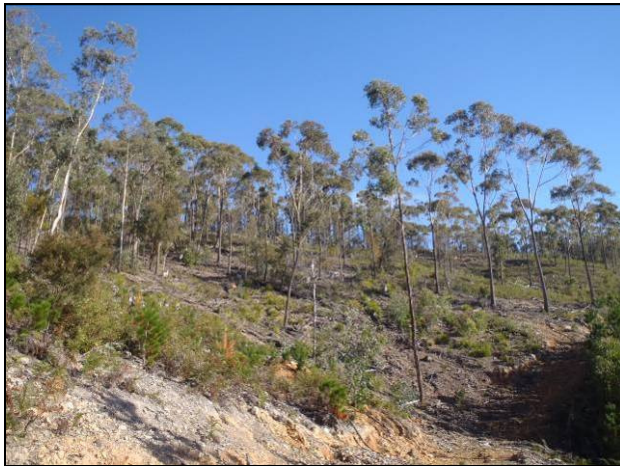
A few sites with a predominately eucalypt canopy and little or no understorey, at this stage, are the result of recent mechanical pine removal. On Skyline Tier a small patch of ironbark forest adjoining the reserve has recently been pine harvested and the eucalypts remain without much understorey (site 3). The black gum forest at site 15 was at a similar stage of pine removal three years ago and its understorey is regenerating well now.

*Figure 16. Site 3: Ironbark canopy remaining after pine harvest with Feller Buncher six months ago.*

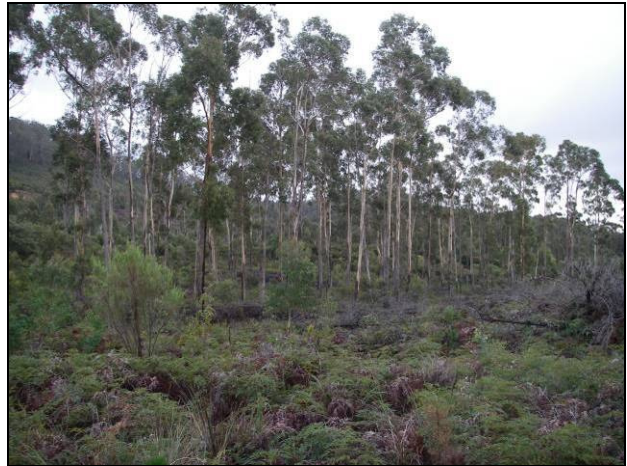
*Figure 17. Site 15: Black gum remnant three years ago after Feller Buncher pine removal.*

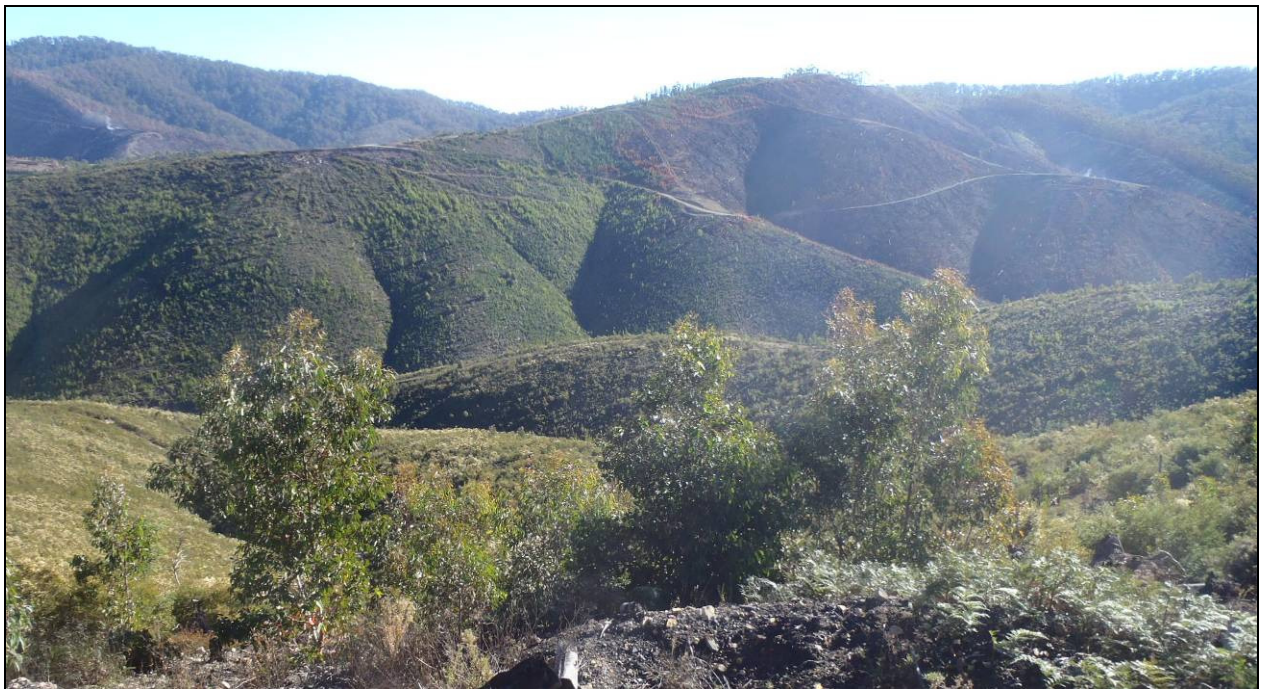
The regenerative effects of a hot burn following harvest are clearly apparent in site 23, Sunshine Hill, (see 3.5 before and after images) which underwent an unplanned burn two years ago following harvest. Now, in May 2013 Sunshine Hill is covered with native regeneration and is on the way to being a successful restoration site with very little input of other resources. Site 27 is similarly regenerating following post harvest fire. It is likely that sites 25 and 29 will regenerate similarly and they should be monitored and follow up pine control management applied as a priority.

*Figure 20. North west from site 23 to site 27 regenerating following post-harvest fire, with site 25 recently burnt.*

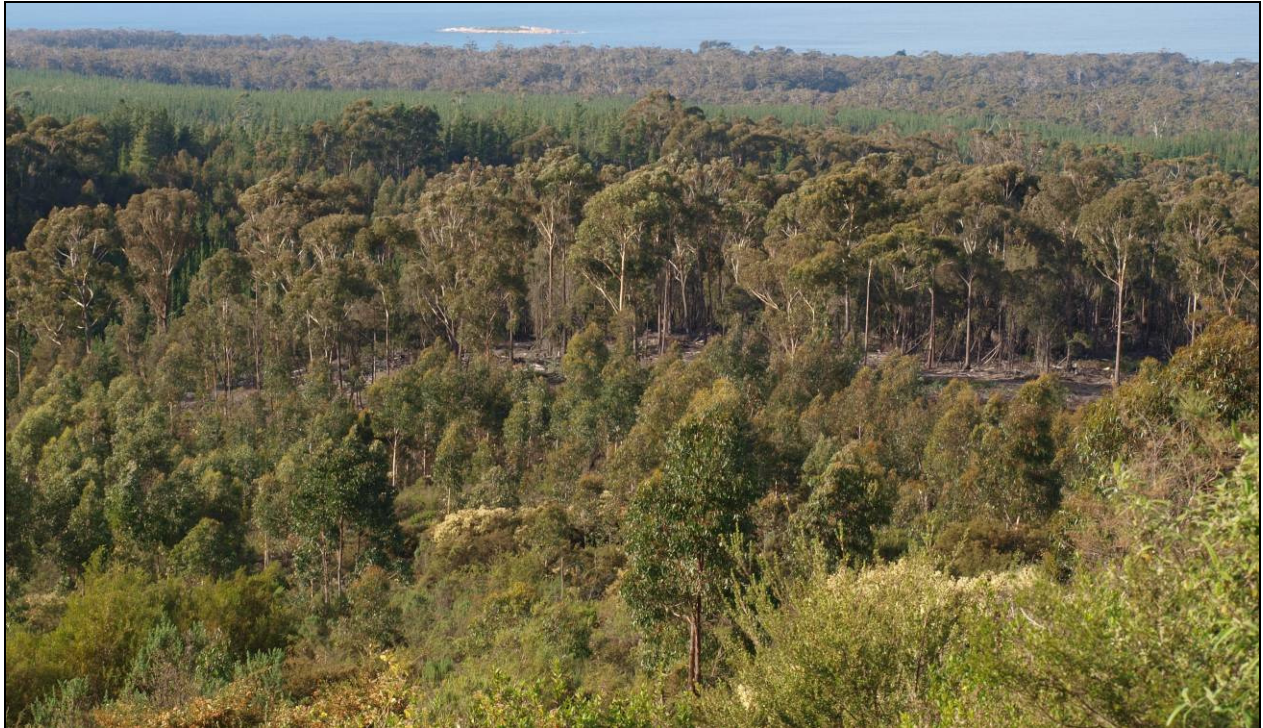
*Figure 28. Yarmouth Creek catchment, ironbark forest regeneration: site 14 in foreground having undergone pine removal with chainsaws; mature eucalypts remaining in site 15 in the middle where the Feller Buncher has recently been removing pine; and site 19 in the background, still to be harvested.*

Sites which have retained their native vegetation or have been restored usually have riparian areas in reasonably good or very good condition. The Yarmouth Creek catchment is in this category where careful restoration work has been carried out. There is further pine removal to be undertaken in this catchment and the same degree of care should be taken to maintain the quality of restoration works and riparian habitat.

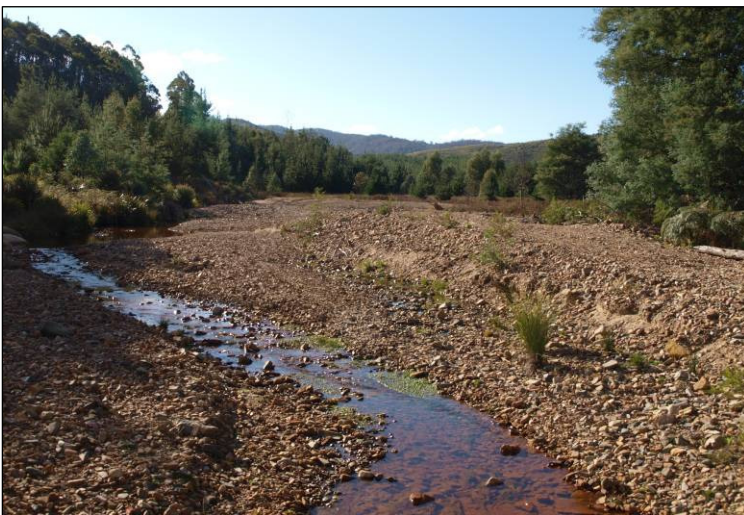
It is evident that currently a greater proportion of streams are degraded or at risk of degradation than in good condition throughout the plantation.

*Figure 31. Arm Creek downstream of site 29: Regeneration and channelling is occurring in widened stream channel. Pine removal from the riparian zone should be mechanical or manual. Note the accrued coarse sediment and discoloured water from upstream impacts.*

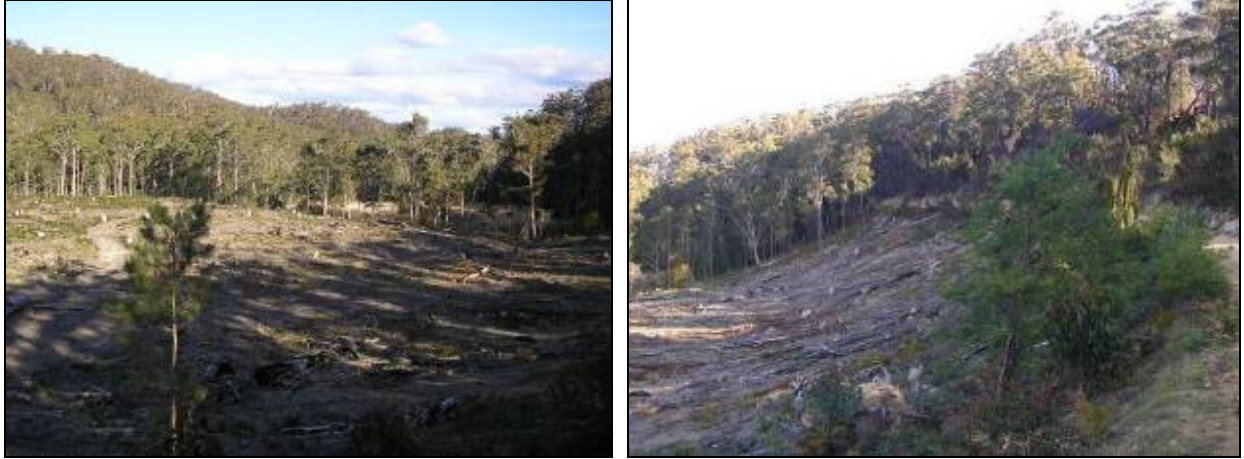
The Trout Creek site has been an exceptional success as a result of manual weeding and having a viable native seed source on site and close by.

*Figures 32 and 33. Trout Creek site: 2006, southeast and south.*

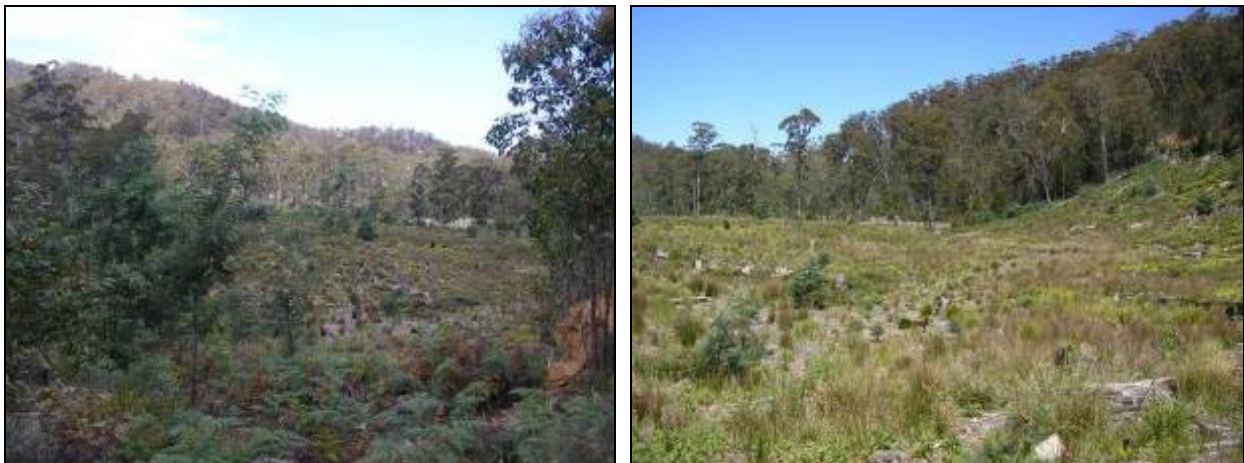
*Figures 34 and 35. Trout Creek site: 2009, southeast and south.*

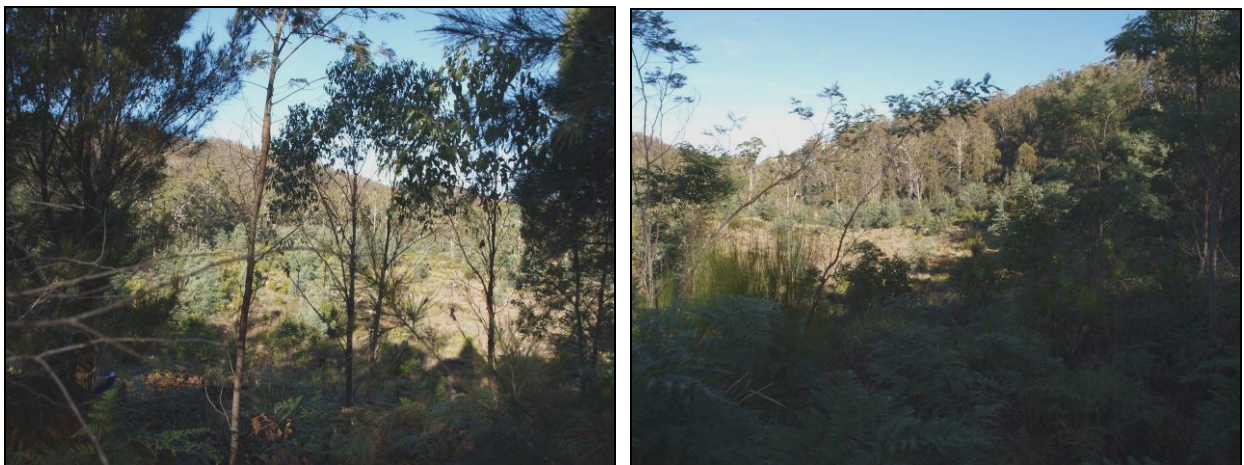
*Figures 36 and 37. Trout Creek site: 2013, southeast and south.*

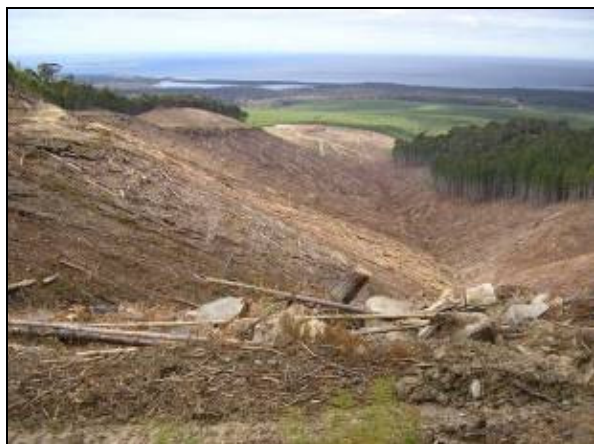
The Diana's Basin site below was not burnt after harvest 7 years ago and, although native regeneration has been excellent, the pines are dense and persistent. The steepness of the slope and extent of the area means that manual and mechanical controls are not ideal and are inefficient. Had the site been burnt it is likely that regeneration now would be as good as site 2.

*Figure 38. Diana's Basin site: 2006, harvested and not burnt.*

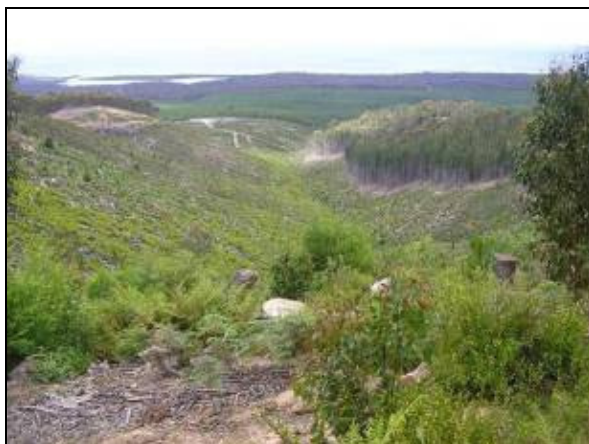
*Figure. 39. Diana's Basin site: 2009, good native regeneration.*

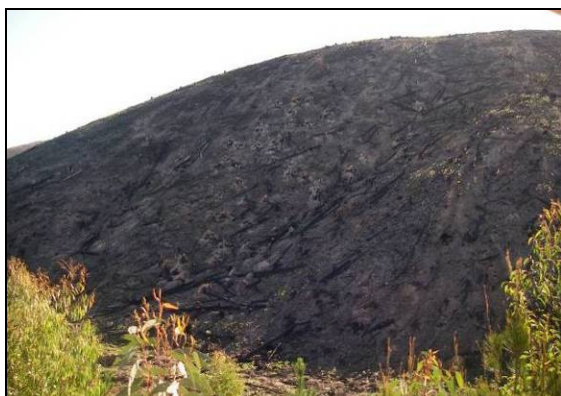
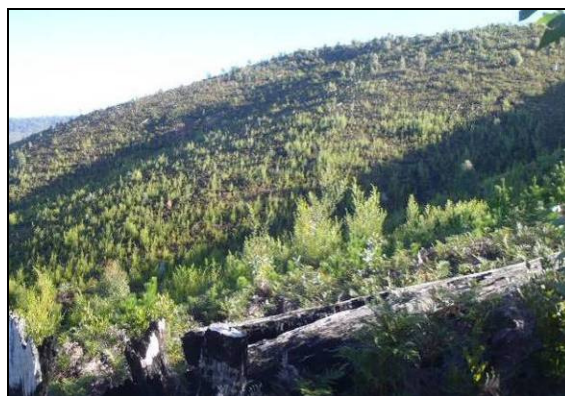
Site 23, Sunshine Hill, was a dramatically bare sight following an unplanned burn two years ago. However, the hill is now covered in native regeneration with very few pines. Follow up manual weeding will remove the pine in a short time and then it is a matter of maintenance with follow up annual weeding until pines are eradicated.

*Figure 41 Sunshine Hill: 2011 after hot fire. Figure 42. in 2013 with hardly a pine and excellent native regeneration.*

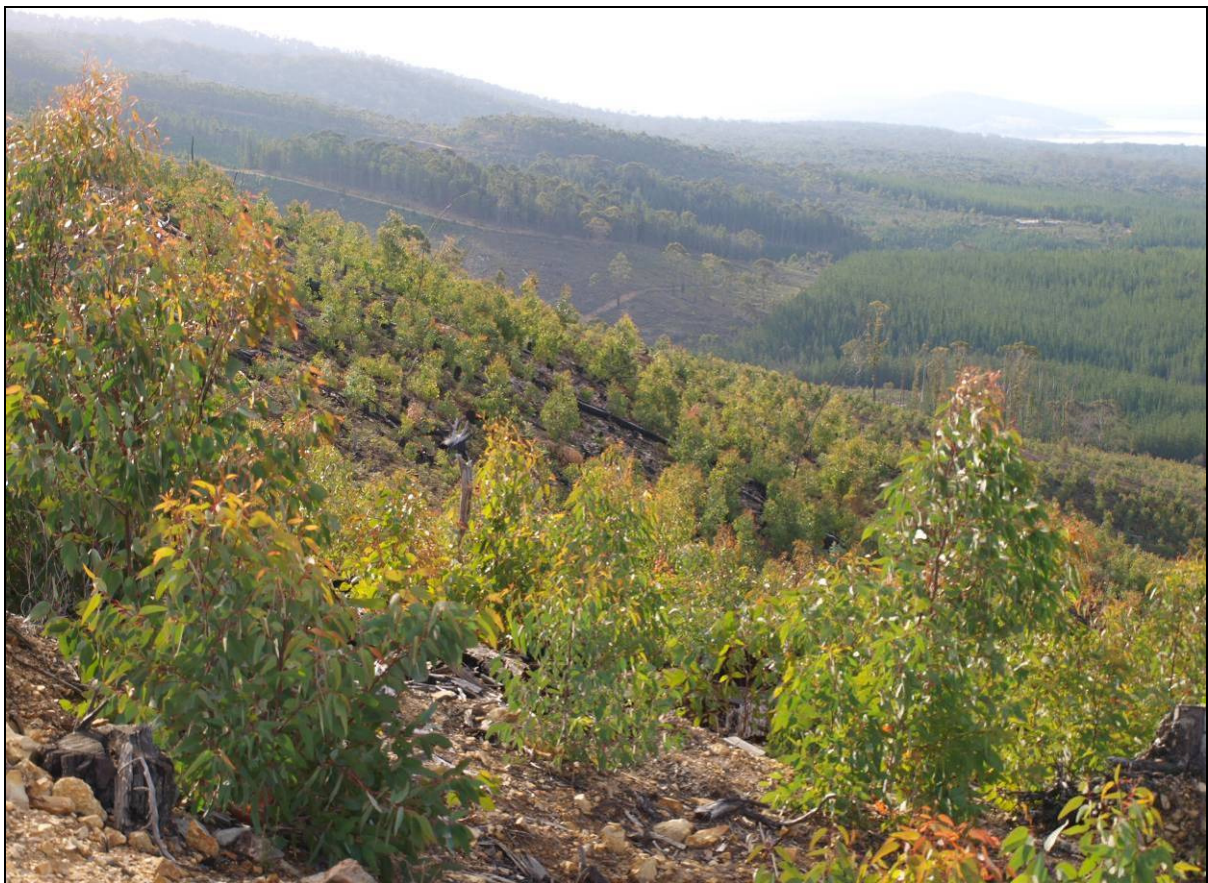
*Figure 43. Site 17: Was harvested, burnt and aerial seeded with eucalypts. Follow up pine control has been possible manually.*

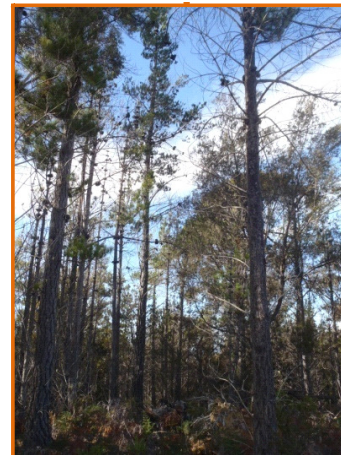
Site 13 Appears poor

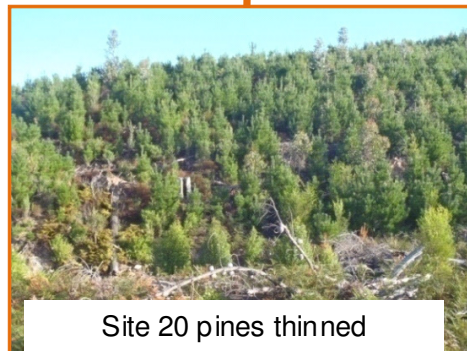
**Harvested, planted,  
thinned into rows**

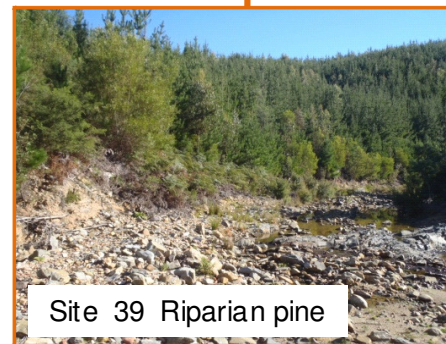
**Riparian pine**  
Pine and native vegetation  
Dense pine regrowth  
Areas planted and harvested  
through water bodies  
No native buffer zone or buffer  
zone less than required

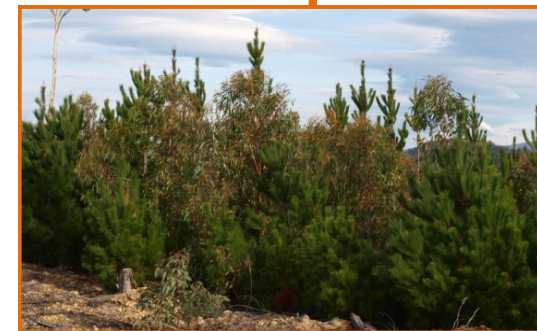
Site 20 Failed or poor quality  
dense pine , steep slopes, native  
regeneration present but not viable  
without a burn, burn soon before  
pines get very big.

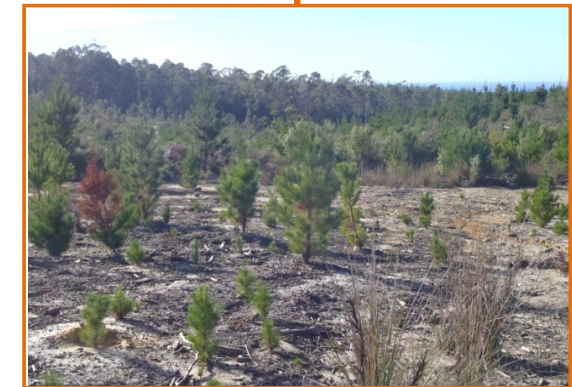
Site 9 no understorey, little native regeneration, pine appears to be failing

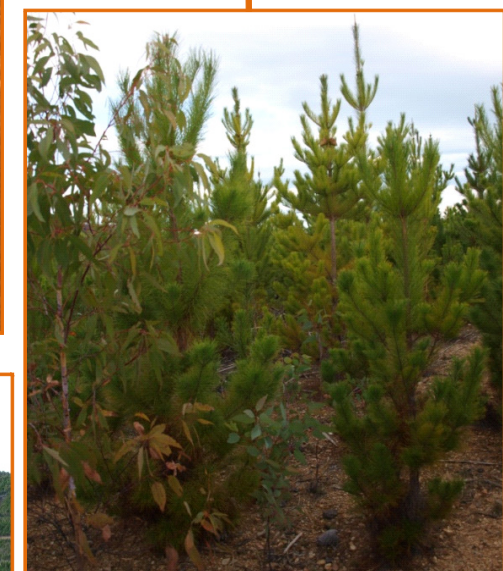
Site 43, poor native understorey,  
pines producing cones

Ensure post harvest burn, may need to introduce slash for fuel to ensure hot burn, sites may require re-seeding with eucalypts and understorey species, monitor and maintain, manual or mechanical follow up control

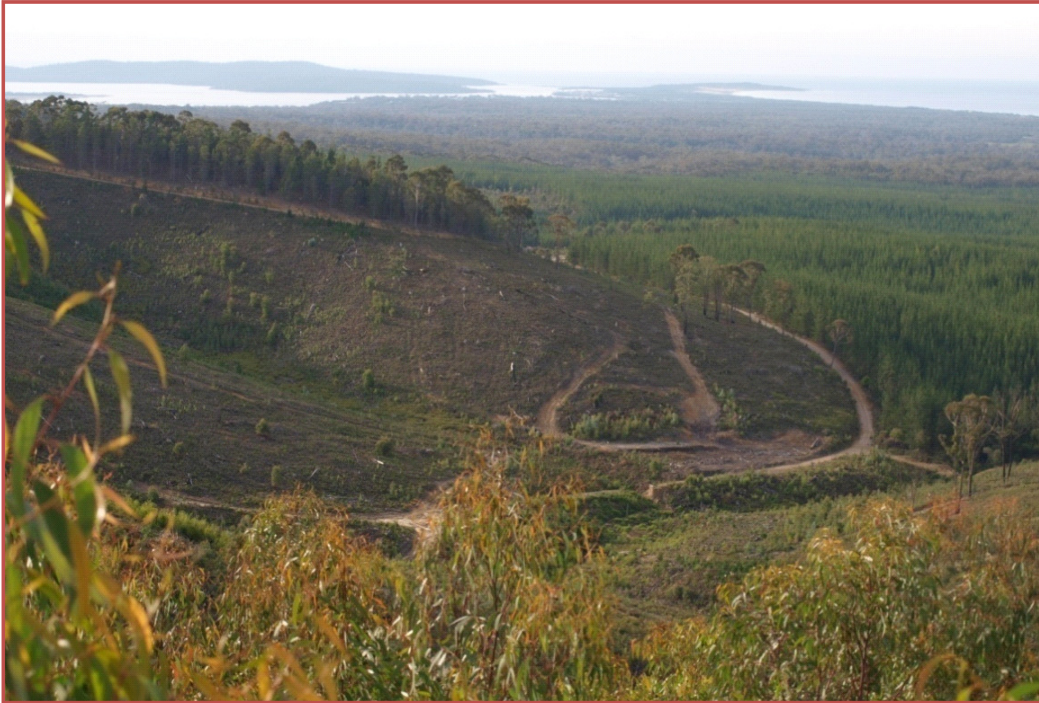
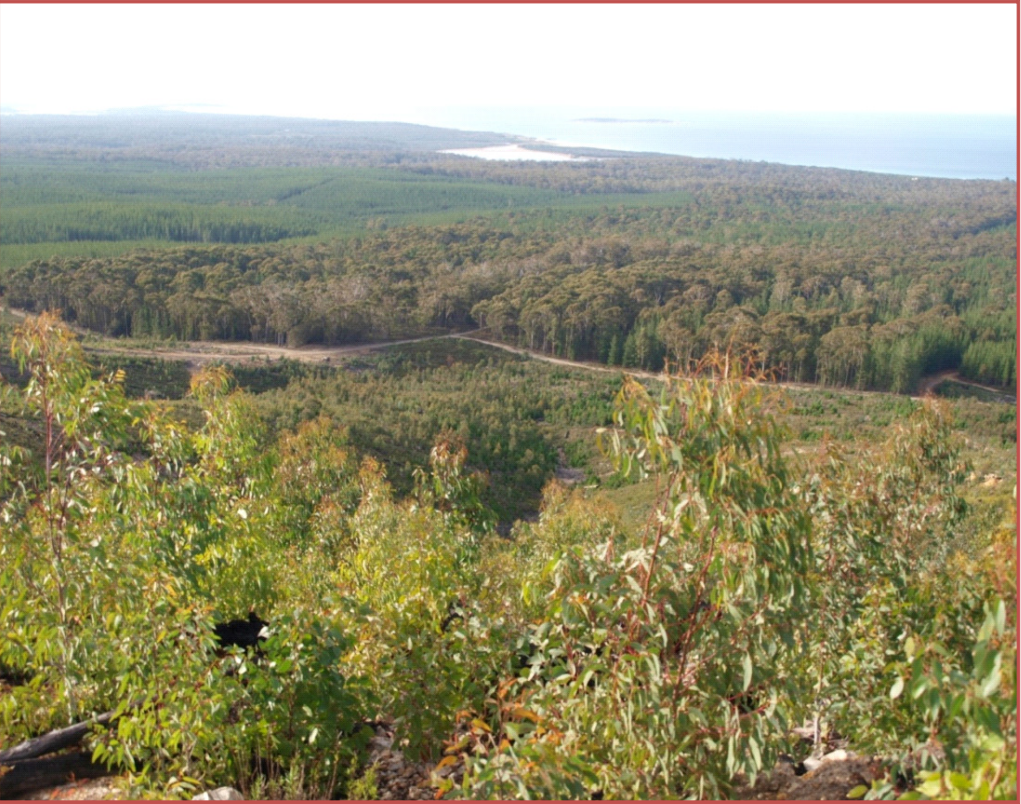
Tall ironbark regeneration on upper slope, site 17 in foreground. Regenerating sub-catchment (site 17) and gully, very little pine remaining. Harvest pine (site 19) in stages and restore to native with hot burns and pine control.

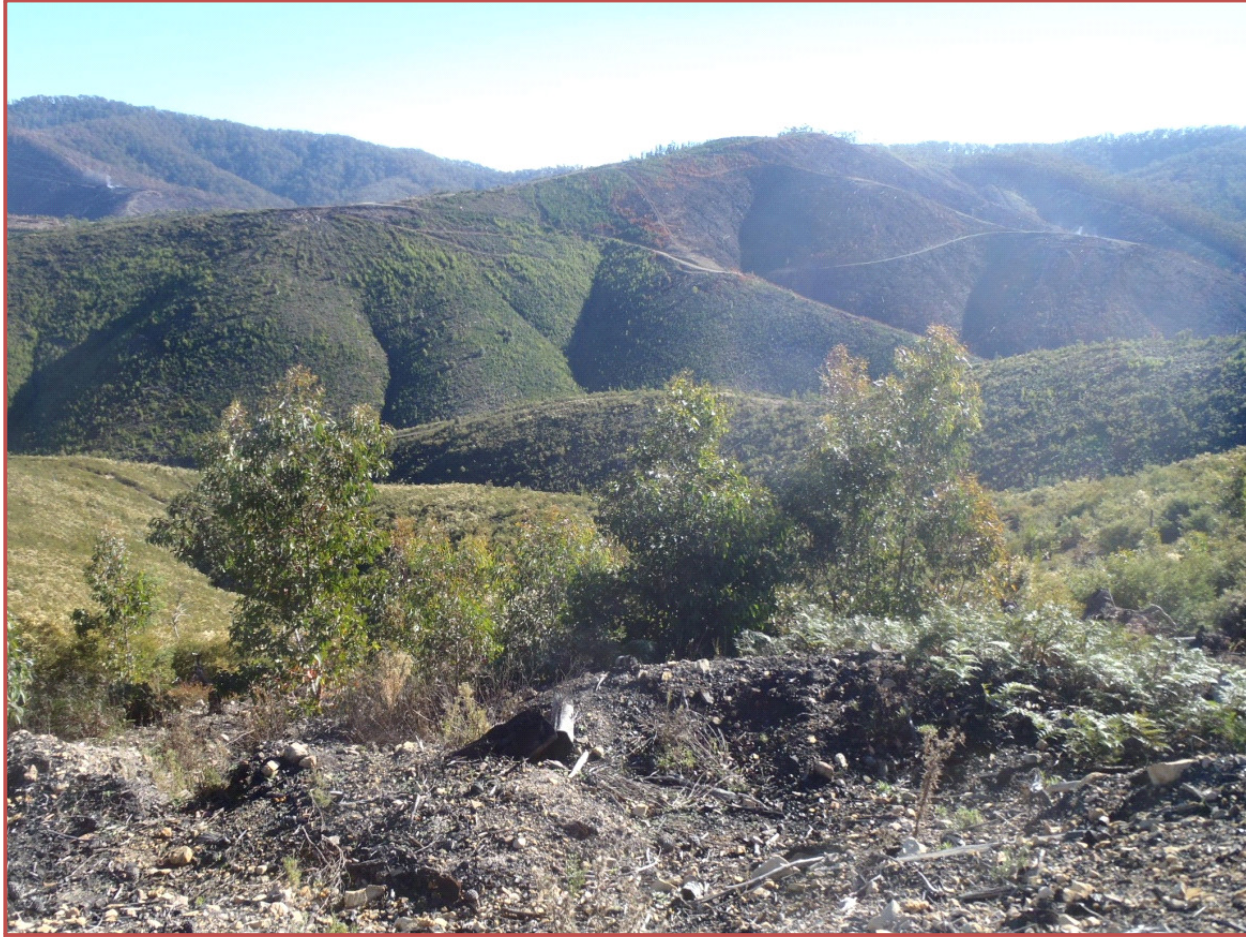
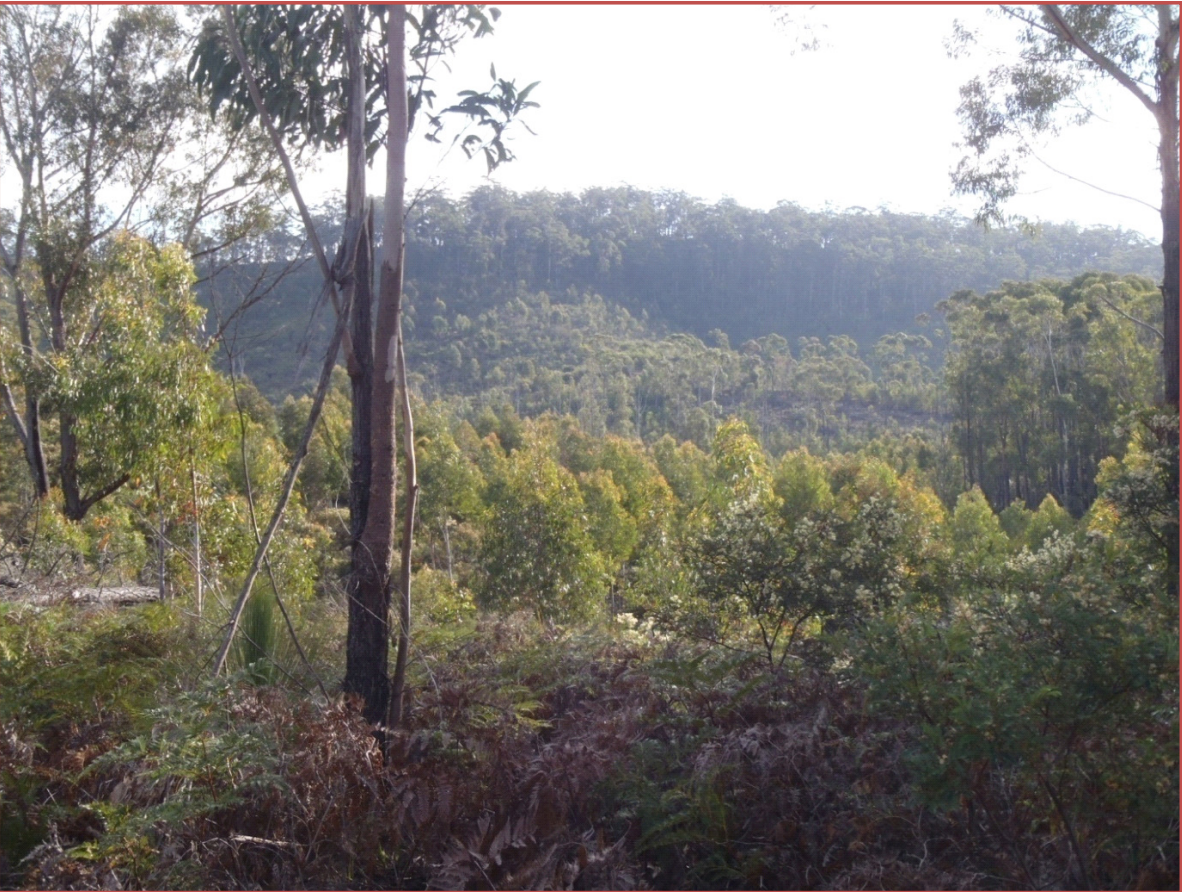
Restoration will connect the east coast with Skyline Tier (upslope in foreground) and restoration areas on the western slopes of the plantation below left, sites 23, 27.

From Sunshine Hill ,site 23, looking north west to site 27 regenerating after a burn, and sites 25 and 29, recently harvested and burnt. This whole area is well on the way to being native regeneration with very little pine and will connect the eastern side of the plantation (via sites 26 and 17) with the Constable Creek - Loila Tier Reserve.
